# Front Floor Illumination Lamp Package Installation (Instruction ID: 86559304)

86559304

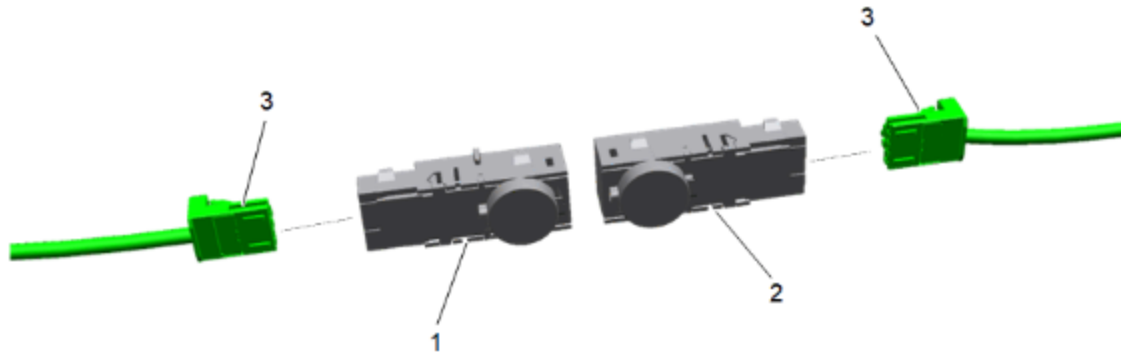
**Note:** Cavity 19 can be used if there is a wire already in cavity 18.

11. Remove connector TPA from body harness connector X210, disengage connector lock and remove cavity plug from cavity 18 on the body harness connector. Refer to [Inline Harness Connector End Views](#) in Vehicle Service Manual for connector disconnection and disassembly.
12. Insert terminal of Green Wire from harness in to cavity 18 of body harness connector X210, make sure terminal is inserted fully.

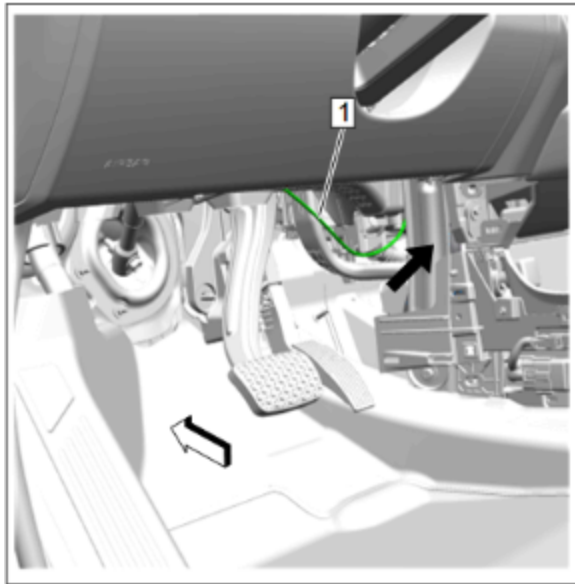
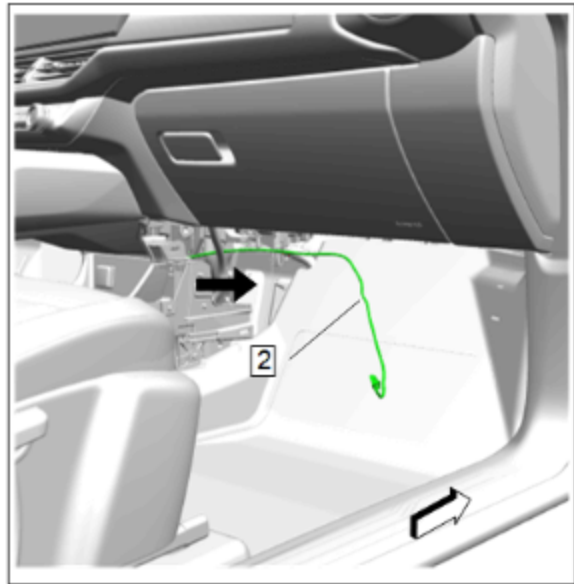
16. Install the LH/Driver RGB Lamp (1) (PN: 86565111) onto the backside (B-Surface) of the HVAC duct/panel's slotted hole (2), and turn clockwise to secure the lamp onto the panel.
17. Connect the LH wire harness connector (3) (the shorter wire harness branch) onto the RGB lamp connector (1).
18. Remove the left front floor console extension panel. Refer to [Front Floor Console Extension Replacement - Left Side](#) in Vehicle Service Manual.
19. Remove the right front floor console extension panel. Refer to [Front Floor Console Extension Replacement - Right Side](#) in Vehicle Service Manual.
20. Remove the right instrument panel lower trim panel insulator. Refer to [Instrument Panel Lower Trim Panel Insulator Replacement - Right Side](#) in Vehicle Service Manual.

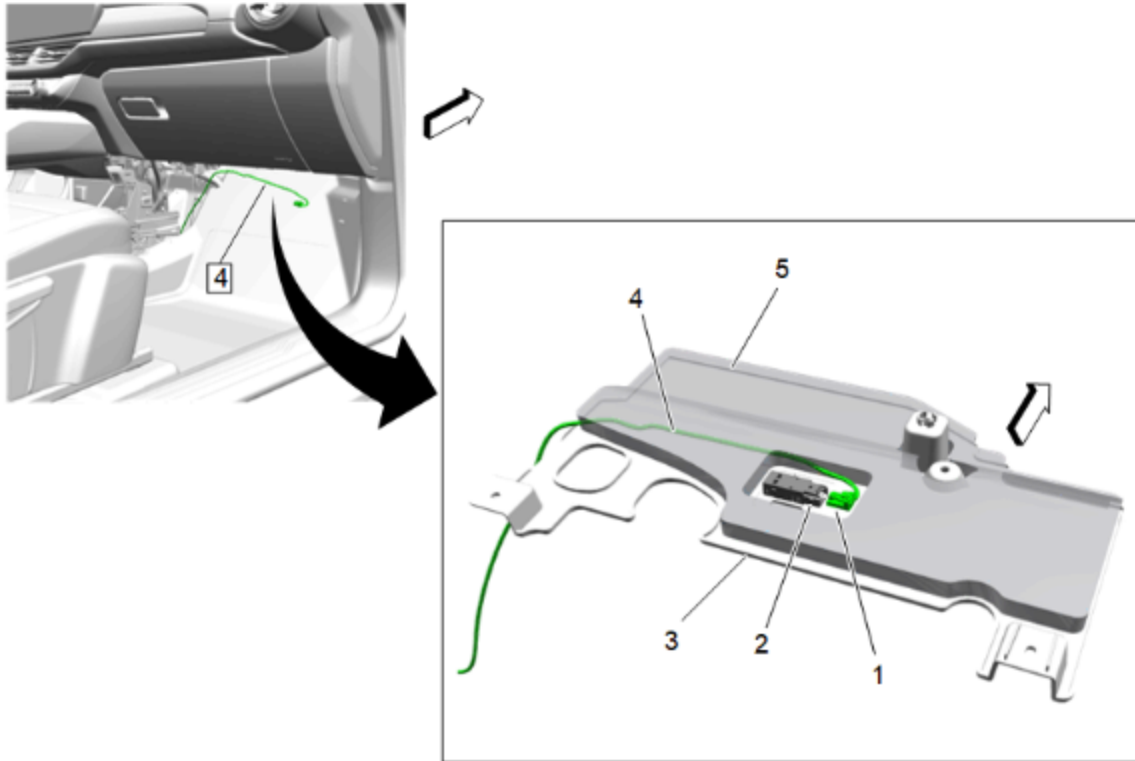
22. Install the RH/Passenger RGB lamp (1) (PN: 86560537) onto the backside (B-Surface) of the RH/Passenger underside panel's slotted hole (2), and turn clockwise to secure the lamp onto the panel.

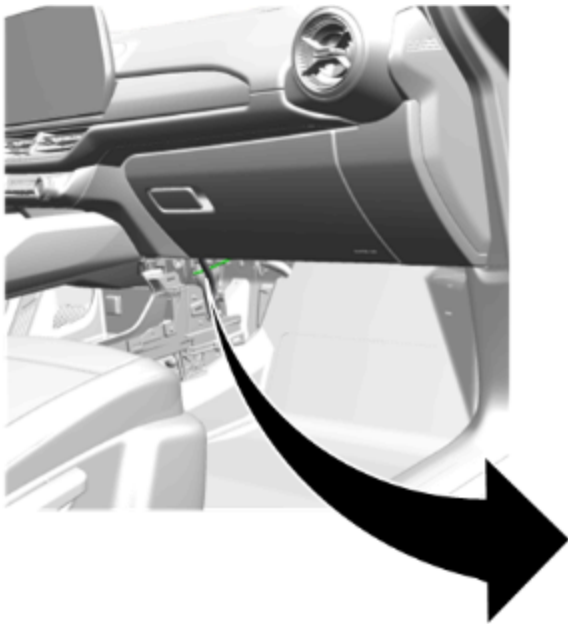
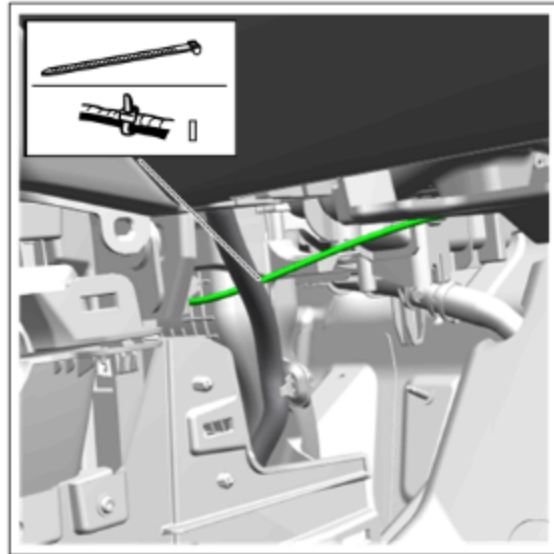
23. Feed wire harness (4) under the B-Side felt insulation (5) of the underside panel (3) (RH/Passenger).
24. Connect harness connector (1) to lamp (2).
25. Reinstall the right instrument panel lower trim panel insulator. Refer to [Instrument Panel Lower Trim Panel Insulator Replacement - Right Side](#) in Vehicle Service Manual.

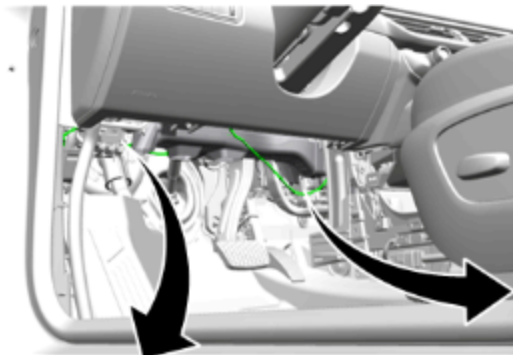
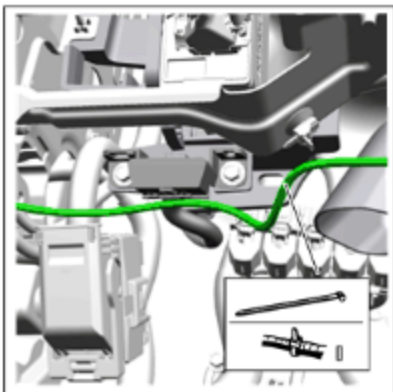
26. On the passenger side, secure the accessory harness to the vehicle harness with supplied tie strap. Make sure harness does not come in contact with any sharp edges or moving parts. Trim excess off tie strap.

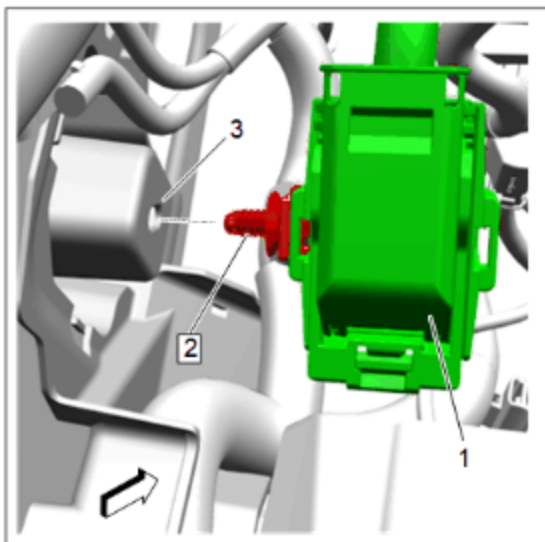
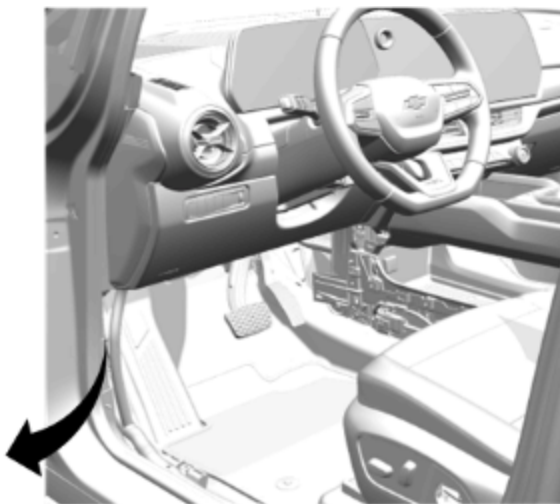
31. Reconnect X210 instrument panel harness connector (2) to the body harness connector (3). Refer to [Inline Harness Connector End Views](#) in Vehicle Service Manual for connector connection.
32. Install cover (1) to connector.
